TRICKLE IRRIGATION: EMITTER CLOGGING AND OTHER FLOW PROBLEMS

R.G. GILBERT, F.S. NAKAYAMA, D.A. BUCKS, O.F. FRENCH and K.C. ADAMSON
U.S. Water Conservation Laboratory, 4331 East Broadway, Phoenix, AZ 85040 (U.S.A.)
Contribution from the Science and Education Administration, Agricultural Research, U.S.
Department of Agriculture.

Gilbert, R.G., Nakayama, F.S., Bucks, D.A., French, O.F. and Adamson, K.C., 1981.
Trickle irrigation: emitter clogging and other flow problems. *Agric. Water Manage.*, 3:
159-178.

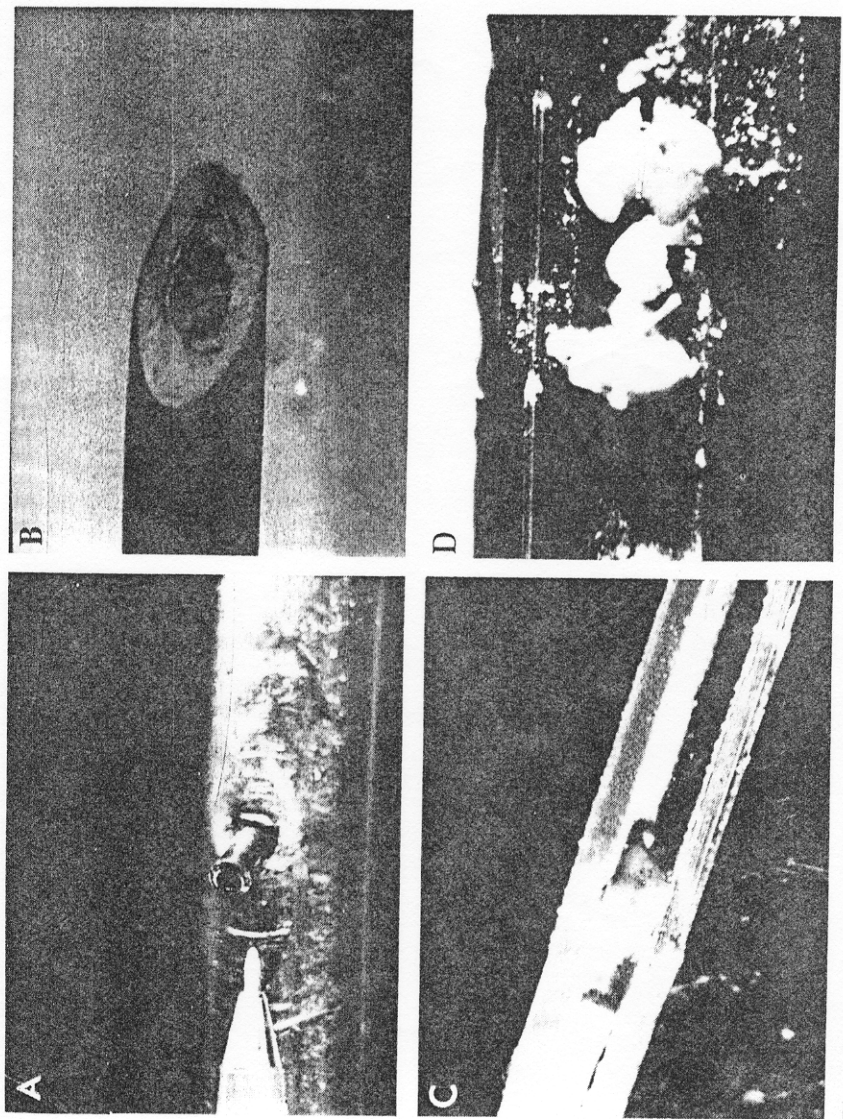
Emitter No. 1 (Fig. 1A) performed efficiently with sand and screen filtration; its clogging rate was 27% (Table IV). Chemical conditioning continuously with acid (Treatment F) maintained flow rates of 71% of design flow (Table V). With only screen filtration (Treatments A and B), the emitter failed after 278 days because of physical clogging. Microscopic examination (Fig. 1) of plugged emitters indicated that physical blockage had occurred mainly at the inlet end of the capillary tubing. This emitter was normally installed in the system by sliding the capillary tube into a hole in the larger polyethylene supply line. Thus, the inlet end could be in the midst of accumulated sediment in the bottom of the supply line. All the other emitters had inlet stems a few millimeters long that were inserted at right angles to the supply line. If the emitter was installed perpendicular to the ground, then water from the upper portion of the supply line would flow into it.

Fig. 1. Emitter 1 with representative clogging problems. A: Exit port of a long-path, capillary tube emitter on a lateral line. B: Plastic particle (white PVC) plugged the entrance of the capillary tube. C: Sand grain and accumulated sediment plugged the capillary tube. D: Plastic saw filling (white PVC) and part of an insect body plugged the capillary tube.

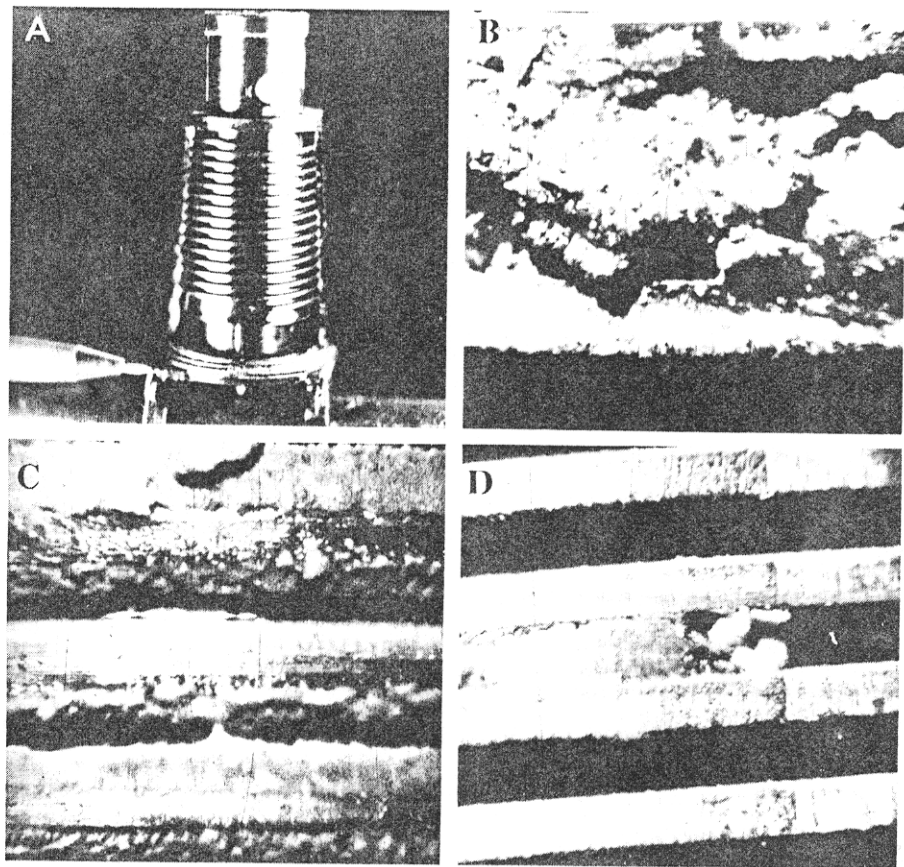
clogging rate was only 5% (Table IV). Sand and screen filtration increased the emitter clogging rate to 18% by unknown clogging factors, but chemical conditioning (Treatments D, E, and F) prevented the clogging and flow-reducing conditions that occurred with untreated water (Treatment C) (Table V). Microscopic examination of the few emitters that clogged indicated that physical and biological factors were responsible, either separately (Fig. 2B, 2C) or in combination (Fig. 2D).

Usually the emitter flow seemed to be reduced first by some physical factor that allowed microbial slimes to develop, especially toward the end of the spiral-groove (Fig. 2C). *Pseudomonas stutzeri* and *Flavobacterium lutescens* were the major bacteria detected in the biologically clogged emitters (unpublished data). The process occurred even in chlorinated systems. As the microbial slime continued to develop in the emitter, its flow rate was further reduced and even more chlorine was necessary for biological control than was present in the treated supply water. Eventually the emitter would have become completely plugged by microbial slime. The microbially plugged emitter was then a potential source of the microbes, which could colonize another emitter when the flow was periodically reduced. Biological slime development of this type was a slow process, but after a few years operation, it could become a very serious problem. Therefore, for long-term operation, periodic chlorination would be recommended.

Fig. 2. Emitters 2 and 3 with representative clogging problems. A: Long-path, spiral-grooved, manual flush type emitters on a lateral line. B: Sediment and carbonates clogged the entrance to the spiral groove. C: Microbial slime development in the spiral groove clogged the emitter. Two major bacteria were detected in biologically clogged emitters: *Pseudomonas stutzeri* and *Flavobacterium lutescens*. D: Plastic particle (white PVC) lodged at molding seam of spiral groove and reduced flow, and then microbial slime development clogged the emitter.

ging rates and flow reduction with sand and screen filtration (Treatments C and D) occurred again with this emitter; again, chemical conditioning (Treatments E and F) prevented these problems. Microscopic examination of clogged emitters showed that a combination of physical and biological factors similar to those described for Emitter No. 2 (Fig. 2) was responsible.

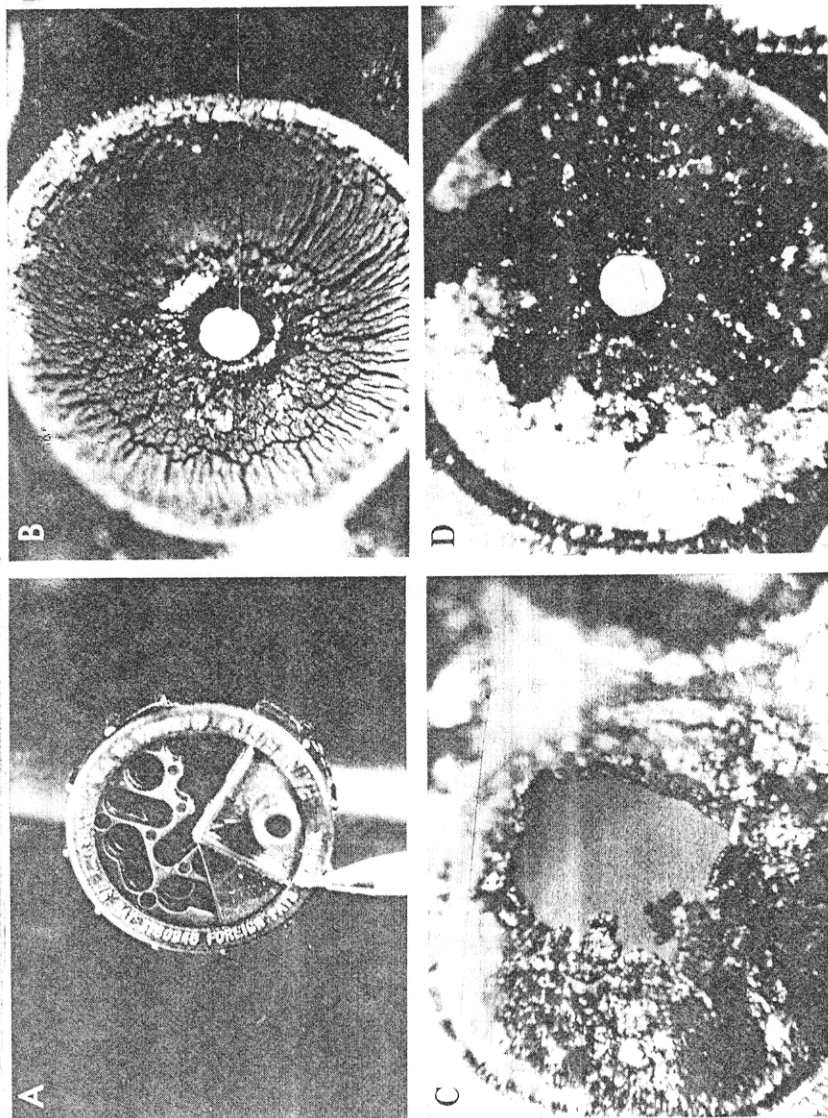
Emitter No. 4 (Fig. 3A) never developed any plugging problems. However, after 18 months with acid and chlorine conditioning (Treatments B, D, and

Fig. 3. Emitter 4 with representative flow problems. A: Multichambered, expandable rubber orifice diaphragm emitter on a lateral line. B: The rubber orifice diaphragm was deformed and deteriorated by chlorine and acid (Treatments B, D, and E) after 18 months. The condition increased flow rates to more than 150% of design flow. C: The rubber orifice diaphragm was extremely deteriorated after 4 years treatment with only screen (50 mesh) filtration (Treatment A). D: The rubber orifice diaphragm was colonized and severely decomposed by microbial action after 4 years treatment with sand and screen (200 mesh) filtration and continuous acid (Treatment F). Also, emitters treated with unconditioned water, Treatment C, were even more severely decomposed.

E), the emitter flow rates were 150% of design flow (Tables V and VI). Apparently, the acid and chlorine reacted with the rubber diaphragm, deforming and deteriorating it (Fig. 3B). Furthermore, after over 4 years operation with unconditioned water (Treatments A and C) flow rates exceeded 150% of design flow. Also, with continuous acid (Treatment F) flow rates were starting to increase (Table V), but only 9% of the emitters had failed after 4 years of operation (Table VI). Microscopic examination of emitters from Treatments A, C, and F revealed considerable microbial colonization, decomposition, and physical deterioration of the expandable rubber orifice diaphragm (Figs. 3C, 3D). Although this emitter performed more efficiently during the first year of operation than all other emitter systems used, our results indicated that the rubber diaphragm material should not be expected to last much longer than 4 years, regardless of the water treatment.

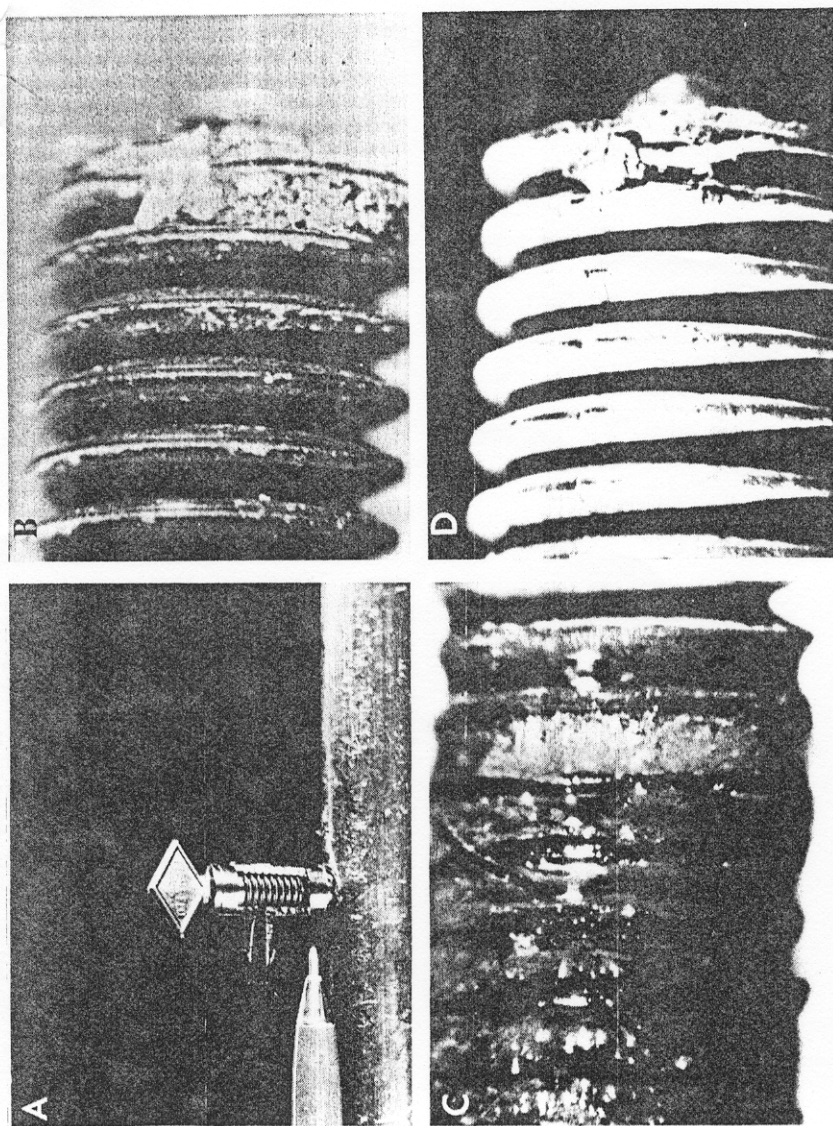
Emitter No. 5 (Fig. 4A) required sand and screen filtration for efficient operation (Table IV). Chlorine and acid (Treatments D and E) kept flow rate higher, but continuous acid (Treatment F) (Table V) did not help. The emitter was similar in design to emitters 2 and 3, but its smaller flow path made it much more susceptible to physical clogging problems (Table I). With only screen filtration (Treatments A and B) it failed after 278 days of operation. Microscopic examination of clogged emitters from Treatments C, D, E, and F indicated that clogging and flow reduction were caused mostly by physical factors, such as sand grains and plastic particles.

Fig. 4. Emitter 5 with representative clogging problems. A: Short-path, spiral-grooved, removable insert emitter on a lateral line. B: Plastic particle (white PVC) and microbial slime clogged the entrance of the spiral groove. C: Microbial slime developed extensively in the spiral groove causing emitter clogging and material deterioration of the plastic insert. D: Organic detritus clogged the entrance of the spiral groove.

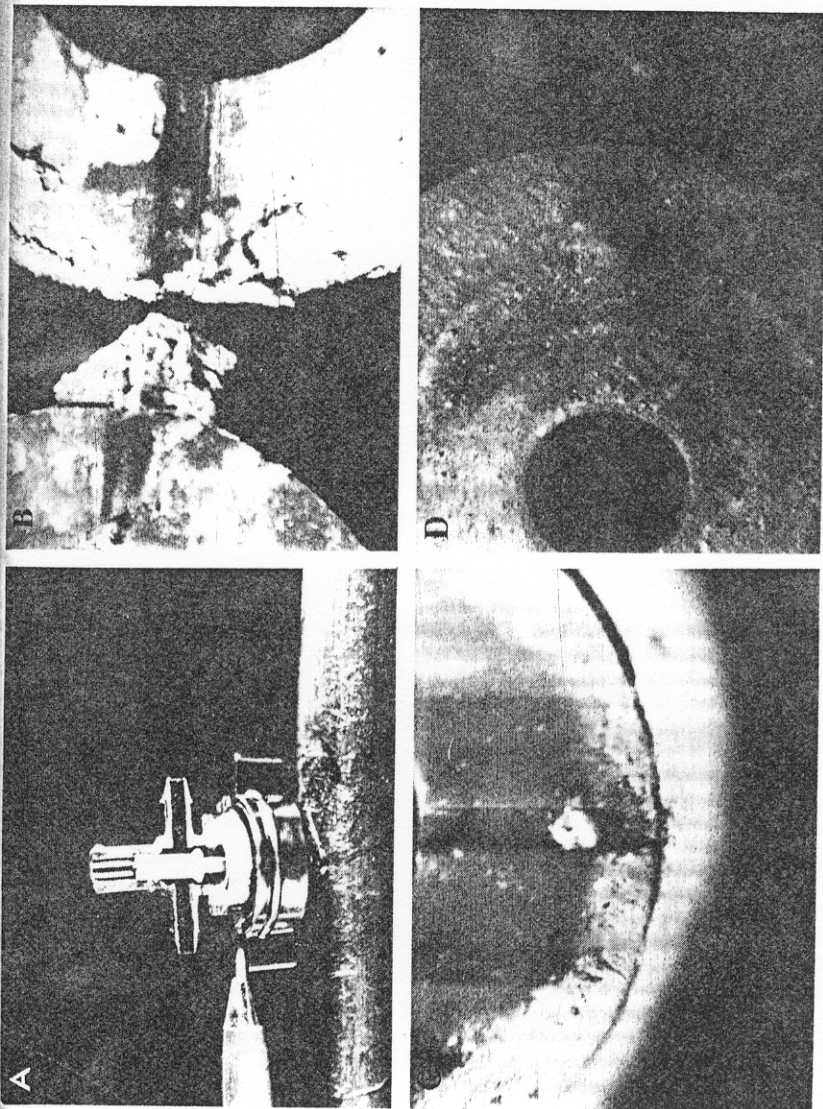
Emitter No. 6 (Fig. 5A) with only screen filtration (Treatments A and B) failed after 278 days because of physical clogging. Sand and screen filtration were required to prevent these problems (Table IV). The emitter, which had internal moving parts, probably would have performed better if it had been inserted into the supply line in an upright position.

We had randomly inserted these emitters into the supply line without attempting to position them upright so that the automatic needle-flush valve would operate as designed in all emitters. Those emitters positioned on the horizontal or below never benefitted from the automatic water pressure-gravity flushing mechanism. In time they became essentially static type emitters and the position of the needle-flush valve controlled the flow rates. If the valve was open, the flow rates were higher than designed. If it was closed, the flow rates were as designed. Without the benefit of the flushing action, the emitter was more susceptible to clogging by accumulated sediment (Fig. 5B) and other particles, such as sand grains (Fig. 5C) and plastic fragments. Furthermore, even with emitters installed upright, flow problems would occur if suspended materials caused the needle-flush valve to stick either closed or open. Therefore, flow rates greater than design flow in Treatments C, D, and E (Table V) were caused by factors that prevented the needle-flush valve from closing properly. The even greater increases in flow rates in Treatments D and E resulted from reaction of the silicone rubber

Fig. 5. Emitter 6 with representative clogging problems. A: Automatic silicon rubber disc/needle-flush valve emitter on a lateral line. B: Sediment closed the needle-flush valve and clogged the emitter. C: Sand grain lodged in flow path of needle-flush valve clogged the emitter. D: A distinct "bulge" on the surface of the silicon rubber disc was caused by chlorine and acid (Treatments D and E). When the bulge was positioned over the flow path of the needle-flush valve, it clogged the emitter; when positioned elsewhere, it prevented closing of the flush valve, which increased flow rates.

disc with the chlorine and acid. The disc swelled and became deformed irregularly, so that the needle-flush valve remained open. Continuous acid (Treatment F) did not produce these effects and maintained the most efficient flow rates for this emitter. Flow rates probably would have been even better with this treatment if the emitter had been installed properly.

Microscopic examination of clogged emitters showed that accumulated sediment and individual sand grain and plastic fragments caused most of the clogging (Figs. 5B, 5C). Emitters receiving chemically conditioned water (Treatments D and E) developed a unique clogging problem. The chlorine and acid had caused the silicone rubber disc to develop a pronounced "surface bulge" (Fig. 5D), that blocked the grooved flow channel of the needle-flush valve and plugged the emitter. The surface bulge could also have contributed to the increased flow rates (Treatments D and E) (Table V) by keeping the flush valve open when the bulge was not positioned over and pressed into the grooved flow channel.

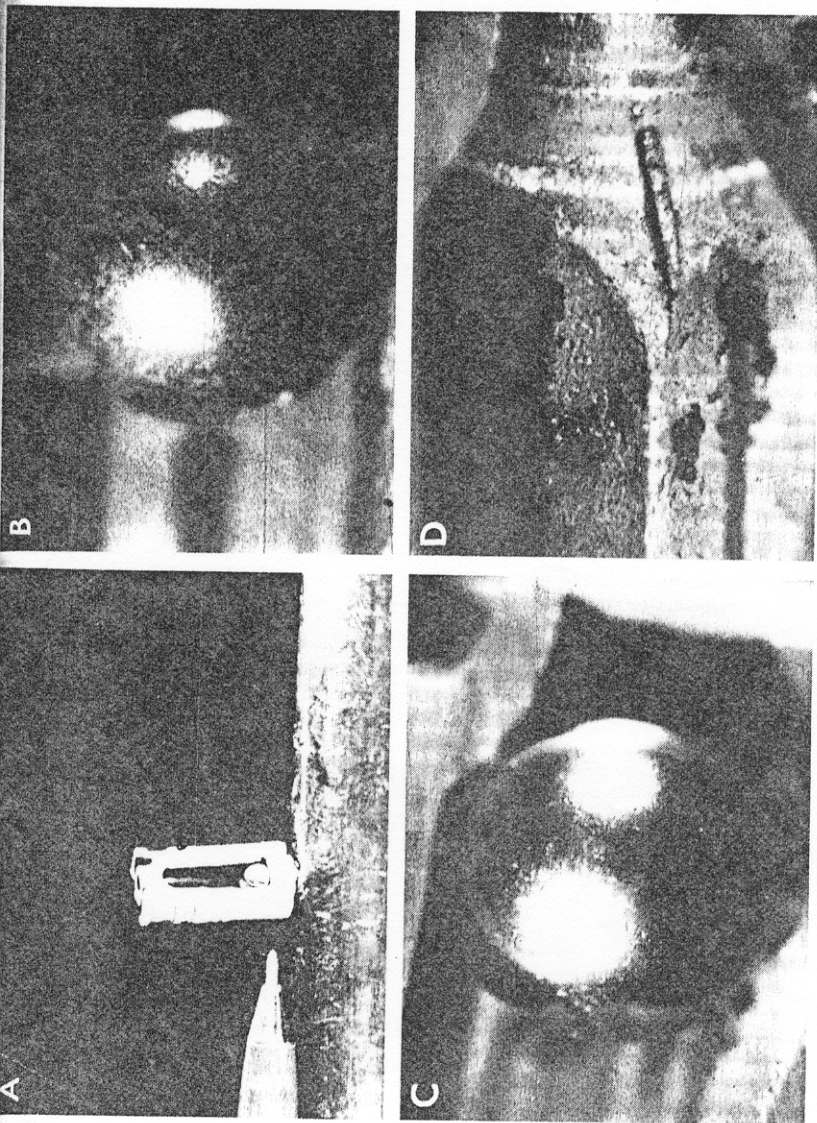
Emitter No. 7 (Fig. 6A) with its moving internal steel ball was also designed to operate in an upright position. Initially, the emitters were installed randomly, which resulted in extremely erratic flow rates that were much greater than design flow. Therefore, it was necessary to reposition each emitter upright so that the water pressure-gravity steel ball-flush device operated properly as designed. Although this emitter still failed after 278 days with only screen filtration (Treatments A and B), performance was very efficient with sand and screen filtration (Treatments C through F). The combined emitter clogging rate with these latter treatments was only 4%, the lowest of any system observed (Table IV). Also, the flow rates were further improved by chemically conditioned water (Table V). Flow rates exceeding design flow (Treatment D) were caused by steel ball-flush valves that would not close properly. Only a few emitters from each treatment were microscopically examined, because no emitters were completely clogged. Generally, the observations indicated that chemical conditioning prevented sediment and scale from adhering to the emitter's internal walls and the steel ball (Figs. 6B, 6C, 6D). This enhanced emitter performance and explained why flow rates were benefited by chlorine and acid (Treatments D and E) (Table V).

Fig. 6. Emitter 7 with representative clogging problems. A: Automatic steel ball-flush valve emitter on a lateral line. B: Steel ball in emitter receiving unconditioned water (Treatment C) was coated with carbonate scale and residue that reduced flow rates, but the emitter was not clogged. C: Steel ball in emitter receiving continuous acid (Treatment F) had an uncorroded surface, which enhanced emitter performance. D: Internal chamber of emitter in Fig. 6C showing the flow channel. When the steel ball-flush valve was closed, the continuous acid (Treatment F) prevented carbonate scale formation and minimized residue accumulation on the emitter walls.

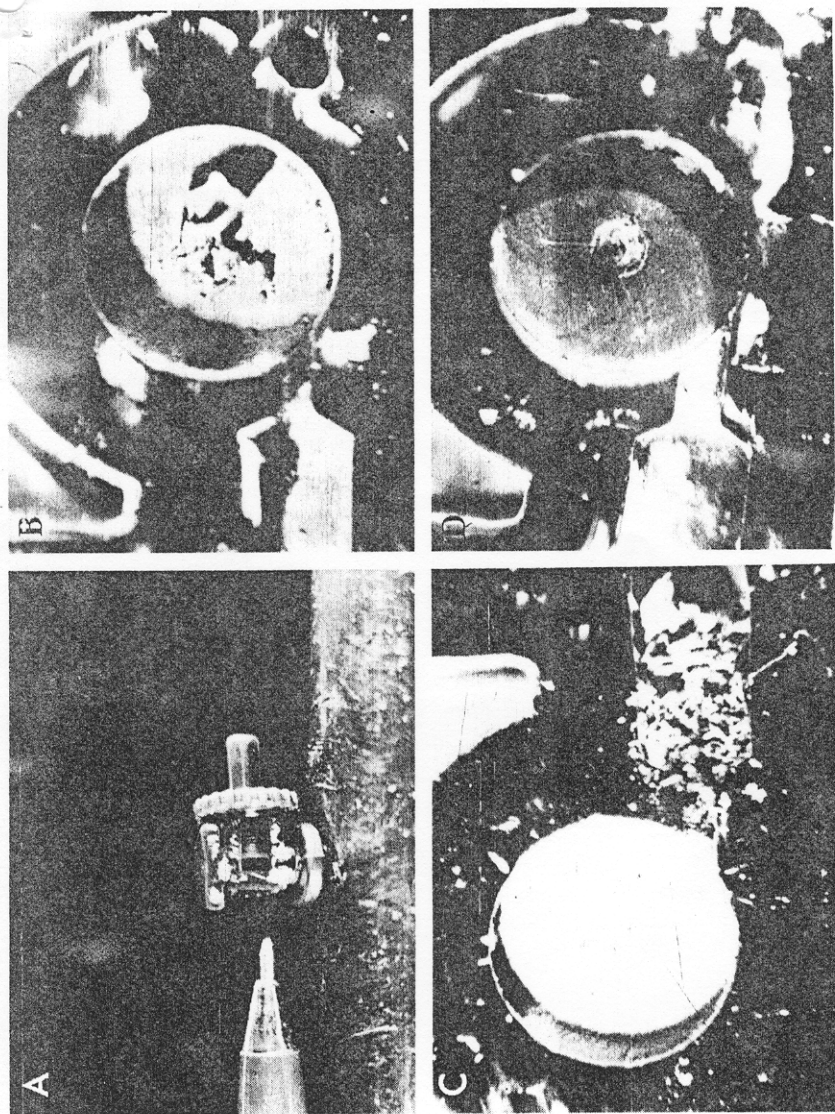
Emitter No. 8 (Fig. 7A) with only screen filtration (Treatments A and B) also failed after 278 days because of physical clogging. The emitter required sand and screen filtration (Treatments C through F) for efficient operation. The combined results from these treatments had an emitter clogging rate of 21% (Table IV). Also, flow rates were maintained nearer design flows by chemically conditioned water, especially continuous acid (Treatment F) (Table V). Microscopic examination of clogged emitters indicated that the small vortex chamber and flow path diameter (Table I) made the emitter more susceptible to physical clogging (Figs. 7B, 7C, 7D).

Fig. 7. Emitter 8 with representative clogging problems. A: Single vortex emitter on a lateral line. B: Plastic particles (white PVC) and organic detritus clogged the entrance of the vortex chamber. C: Plastic particles (black polyethylene) and organic detritus clogged the entrance of the vortex chamber. D: The thorax and body of an ant clogged the exit of the vortex chamber.
